In re Application of:	Carpenter <i>et al.</i>	Confirmation No.:	5405
Serial No.:	09/769,670	Group Art Unit:	2831
Filed:	01/25/2001	Examiner:	Patel, D.
For:	Grounding System for Floating Roofs in Flammable Storage Tanks	Attorney Docket:	RM26ii

**REVISED DECLARATION OF NON-OBVIOUSNESS
PURSUANT TO 37 CFR § 1.132**

RETRACTABLE GROUNDING ASSEMBLY™ (RGA™)

A LOW IMPEDANCE GROUNDING SYSTEM FOR REDUCTION
OF THE BOUND CHARGE IN FLOATING ROOF TANKS

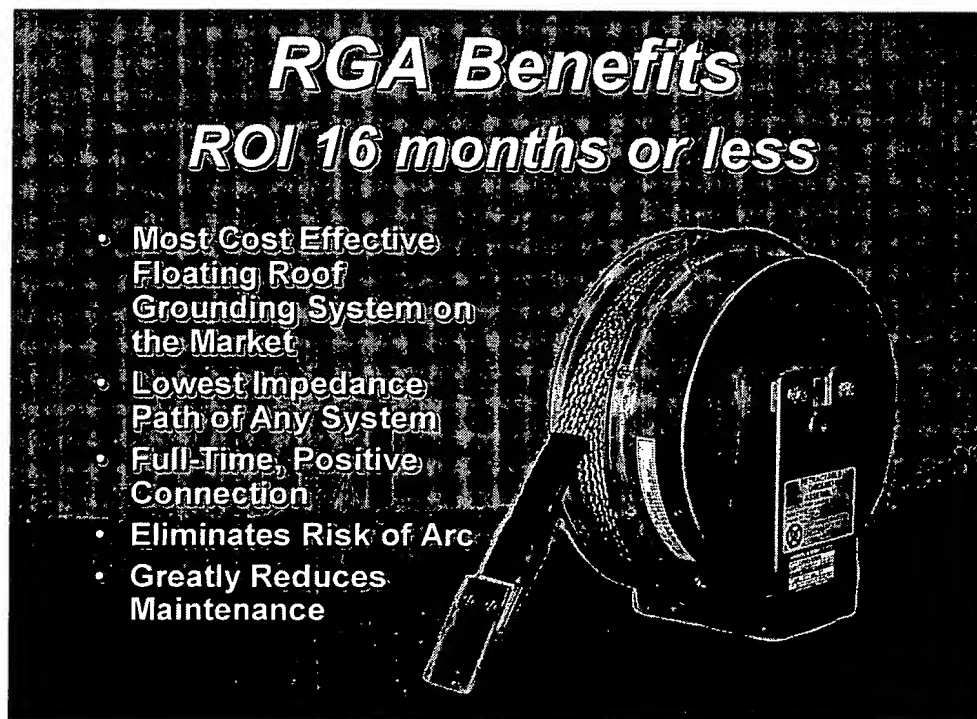
LEC has developed an assembly that will provide a very low-impedance connection to the floating roof grounding and bonding provided in one modest assembly. The LEC Retractable Grounding Assembly (RGA) is 100% effective and is virtually maintenance free. Further, it is independent of the condition of the tank wall and that of any shunts; it also works if no shunts are present. See Figure 10.

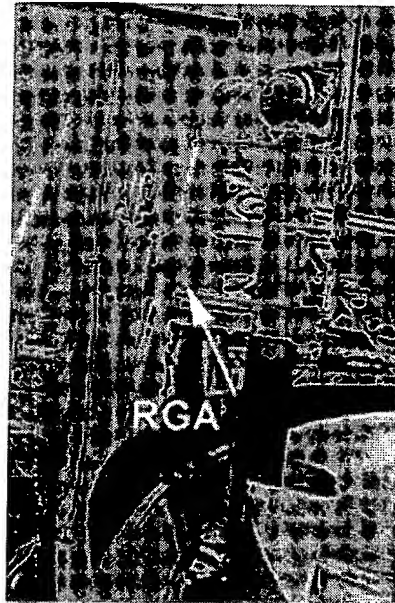
Figure 13 illustrates a typical RGA wall installation as implemented at several tank farms in Israel.
